## REPORTING SERVICE: XR

Report number: VETCT-70603

Pre-purchase radiographs.

Anatomic regions: Stifle, Tarsus/foot, Pelvis/hips

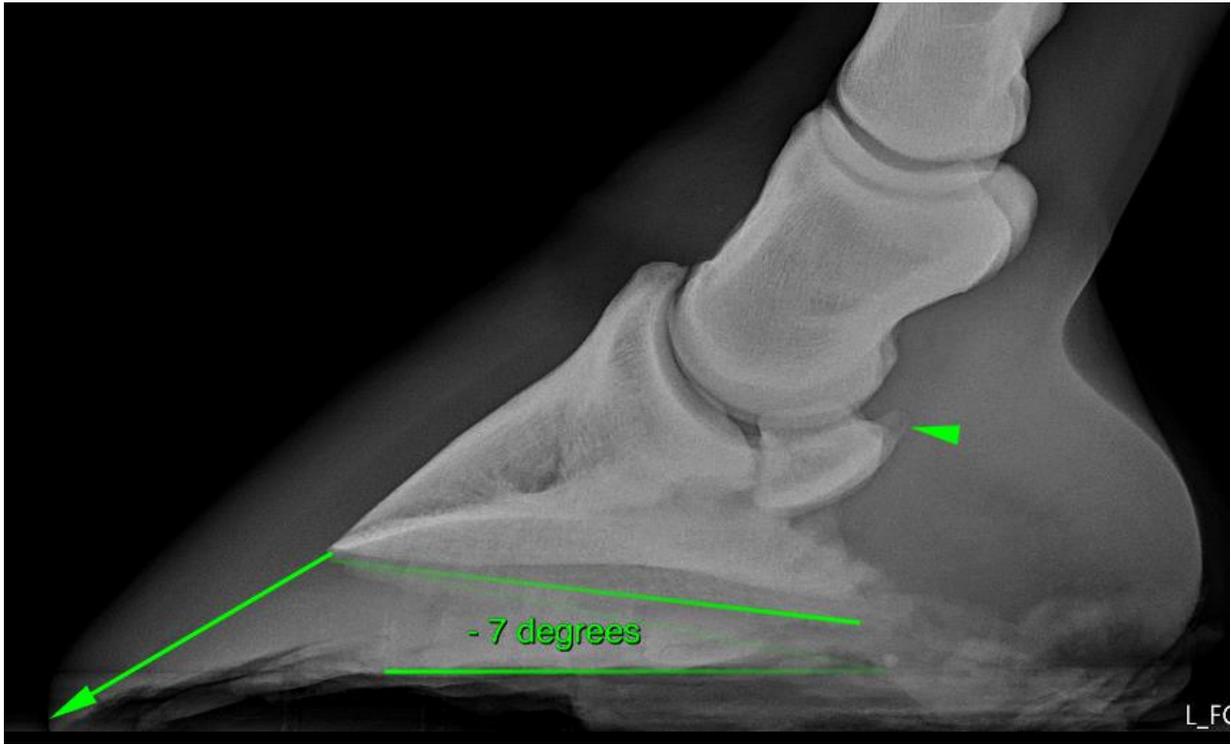
- Bilaterally the toe is very long and overgrown. The line extending distally from the centre of rotation of the distal interphalangeal joint reaches the sole at the junction between its mid and palmar third; which more palmar than expected.

- The angle between the solar margin of the distal phalanx and the sole (palmar angle) is negative, with the palmar processes of the distal phalanx being positioned more distally within the sole than the tip of the distal phalanx. The angle of rotation is LF= -7 degrees; RF= -4 degrees.

- A large smoothly margined enthesophyte is visible at the proximal lateral border of the left navicular bone in the region of insertion of the lateral collateral sesamoidean ligament; a similar but smaller lesion is visible in the right limb. Multiple elongated synovial invaginations are visible at the distal horizontal border of the left navicular bone.

LM view of the left front foot showing the reverse palmar angle (bars) the long toe (arrow) and the large enthesophyte on the proximal border of the navicular bone (arrowhead).

The very long toe in xxxx's feet suggests non-recent trimming and the poor balance might be partially improved by corrective shoeing. Reduction of the palmar angle increases the load of the deep digital flexor tendon and might predispose to injury. Negative palmar angle in the hind feet is often observed and the effect of this finding on the biomechanics of the foot is not well understood.

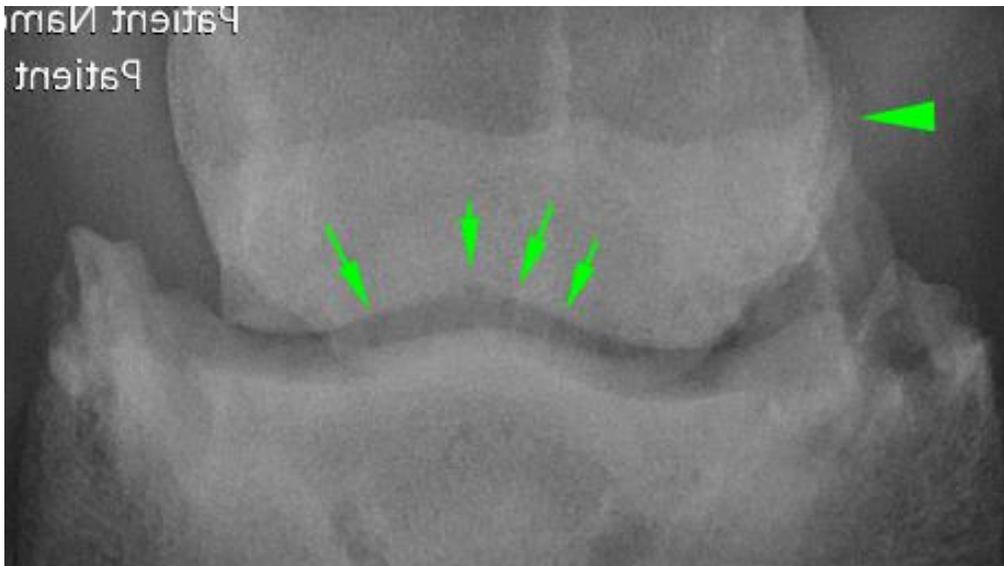
DPrPaDiO view of the left front foot: large enthesophyte at the proximal lateral aspect of the navicular bone (arrowhead) and elongated synovial invaginations (arrows).

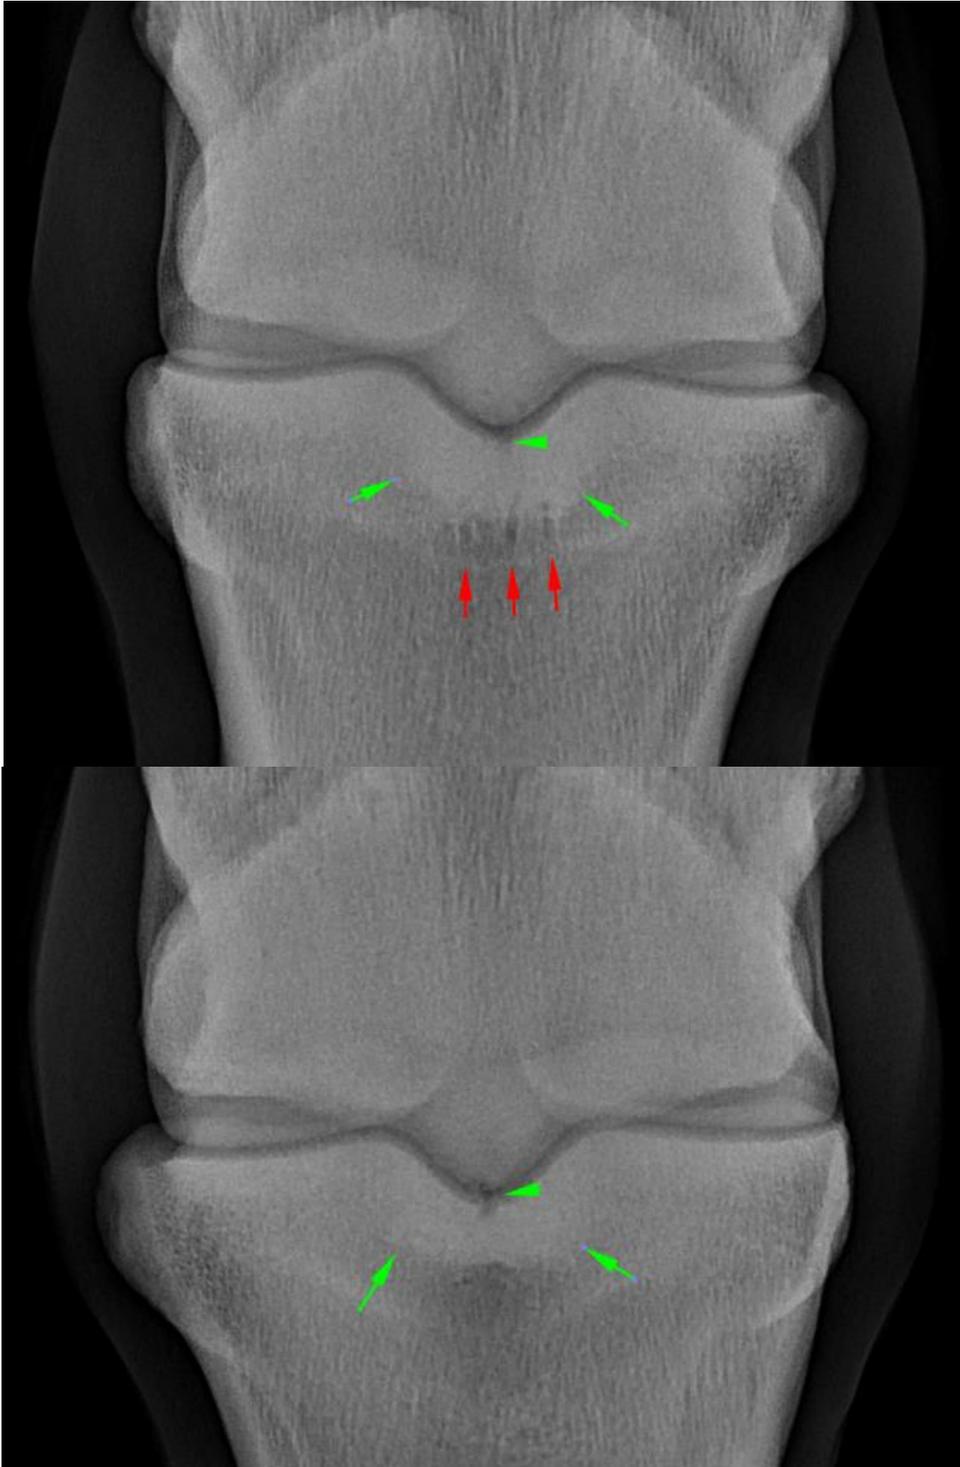
- A short lucent line is visible at the sagittal groove of the proximal phalanx bilaterally. The lucent region is 3mm long. The subchondral bone at the sagittal groove is slightly thickened and has irregular margins bilaterally.
- Distal to the thickened subchondral bone 3 elongated parallel lucent regions are visible in the left proximal phalanx, likely representing enlarged vascular channels.

DPI view of the left and right hind fetlocks showing the small axial lucent region in the proximal phalanx (arrowhead) and the subchondral bone remodelling described (arrows).

Lucent areas in the proximal axial aspect of the proximal phalanx have been associated with abnormal remodelling of the bone secondary to overload and trauma. These lesions have been described in horses with lameness localized to the fetlock and when examined using MRI larger areas of subchondral bone remodelling have been identified in the proximal phalanx compared to what could be observed on radiology only (Dyson et al VRU 2011). This finding should be interpreted based on the result of a clinical examination and expected use for this horse. Further information about the extent of this lesion can be obtained using MRI.
